# Stopping the slide

In his third article on subsidence, Andrew Bussey looks at mitigation and repair works

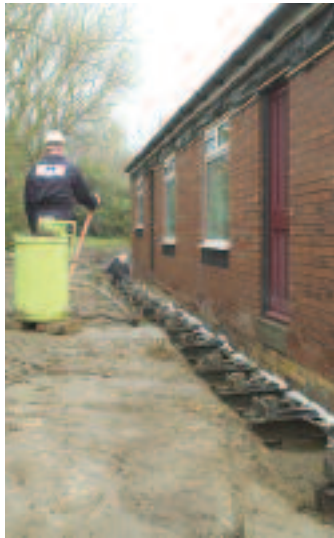
Needle beams can be used as part of an underpinning scheme

The obvious options are underpinning and the technique depends on existing ground conditions. Traditional mass concrete systems are best suited to shallow depths for cost and health and safety reasons. Where greater depth is needed, the use of beam and base underpinning and piling is usually more appropriate and often results in better value and a tighter contract programme. Critical when designing any underpinning solution is understanding the precise cause of a problem and more detailed site investigation works may be needed.

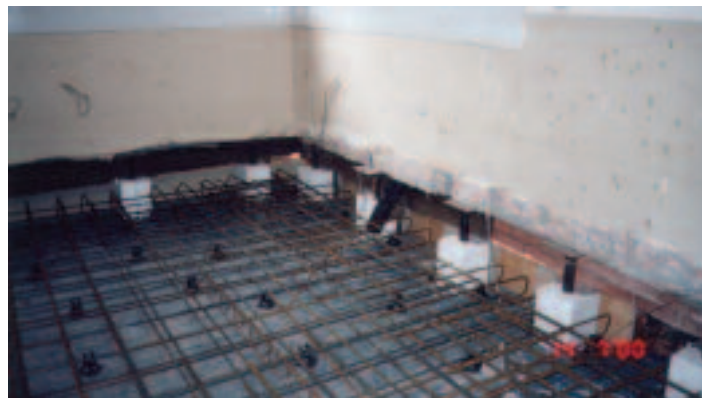
Introduction of a piled raft is one method used to stabilise a property

From the borehole data, we were able to design piled foundations to reinstate support to the building's foundations and cosmetic repair works were then possible.

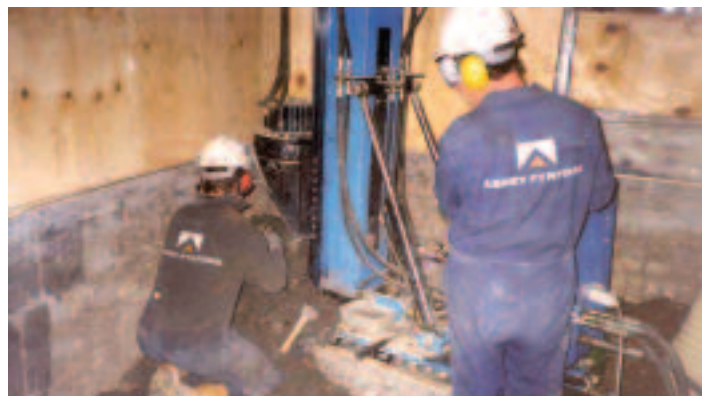
Some piling rigs are small and manoeuvrable for when there is restricted access or low headroom

to specialist underpinning contractors to gauge their views on the most workable scheme. For example, there's little point in planning a deep mass concrete scheme if contractors aren't comfortable with the health and safety implications, or scheduling a piling scheme if the rig can't get to the area. Early dialogue with the property owner and their insurer is essential as these techniques can often be disruptive, requiring property owners to temporarily relocate.
